Pedestrian Mobility and Safety Audit **Phoenix, AZ, USA**

Executive Summary

3200 to 3300 West Van Buren Street Pedestrian Crossings

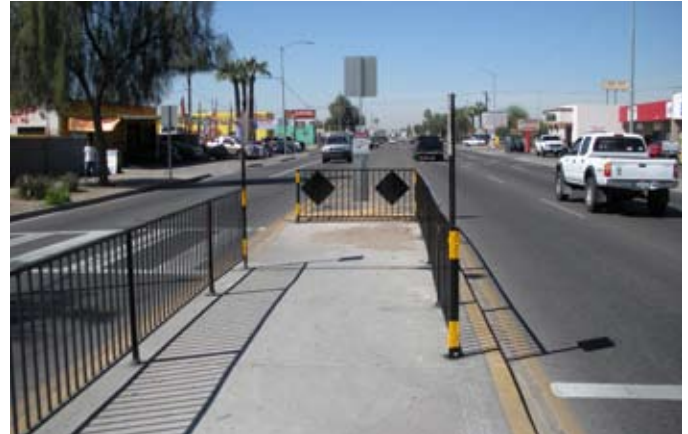
“A two-stage crosswalk consisting of a fenced center pedestrian safety Island with ladder design crosswalks on either side and advanced stop bars on approaches is provided near Van Buren Street and 32nd Avenue. This design forces the pedestrians to face oncoming traffic before crossing the second half of the street. The stagger always has to be in the right direction so the pedestrian turns to the right before crossing the second half of the street. Pedestrians wishing to cross the street at this location need to watch only one approach of traffic and enter the median island, which provides refuge before the pedestrian can safely watch and cross the other half of the street.”²

Example of a two-stage crosswalk.

The crosswalks are offset from each other requiring the pedestrian to look towards oncoming traffic before beginning the second stage of their crossing.

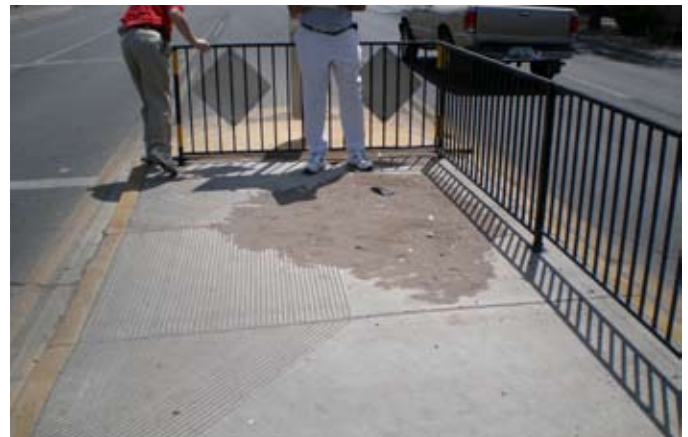
One issue with this design is the amount of sand, dirt and other fine debris that gets trapped in the median island. City staff acknowledged the difficulty in keeping the refuge area free of such material.

Debris build-up in median area.

- **Increase** the visibility of the crossing by installing overhead signs at the crosswalk location.
- **Remove** debris regularly from the median island.
- **Improve** sidewalk locations, where needed.
- **Fix** the light pole turned the wrong way. Lamp/pole needs to be turned toward the road.
- **Consolidate** multiple driveway accesses along the sidewalk, when feasible.

- **Improve** the design of the median island so debris does to accumulate.
- **Install** detectable warning surfaces to enhance the safety for visually-impaired pedestrians.

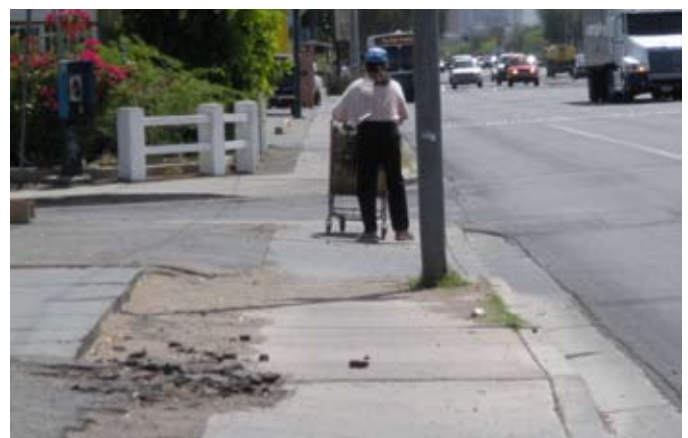
Sidewalk in need of repair.

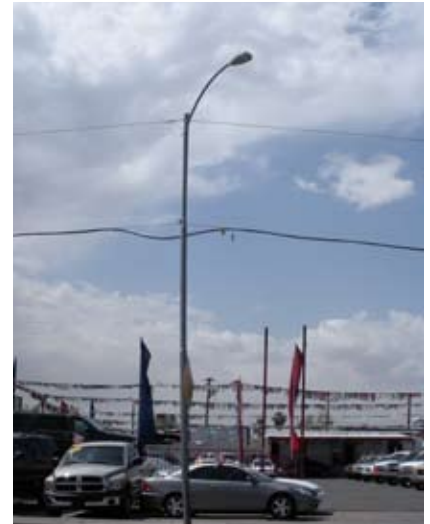
Light pole turned the wrong way.

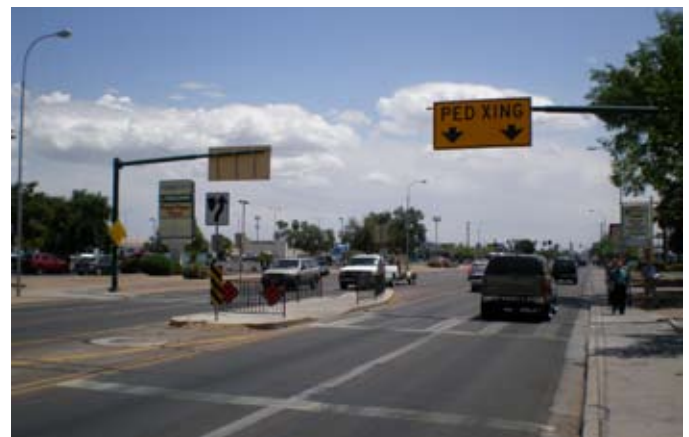
This location is also a two-stage unsignalized intersection crossing. It is much closer to a signalized intersection than the previous location. The crossing is augmented by a large overhead rectangular PEDESTRIAN CROSSING sign on each approach, in order to improve the visibility of the crossing. The review team felt that this location seemed safer than the first. Driver compliance with yielding to pedestrians appeared to be good. Debris also accumulated in the median island of this crossing. The pattern used for the crosswalk is a high-visibility “ladder” style design. It was somewhat faded, but did appear as if it was being regularly maintained.

Overhead sign designating the crosswalk location.

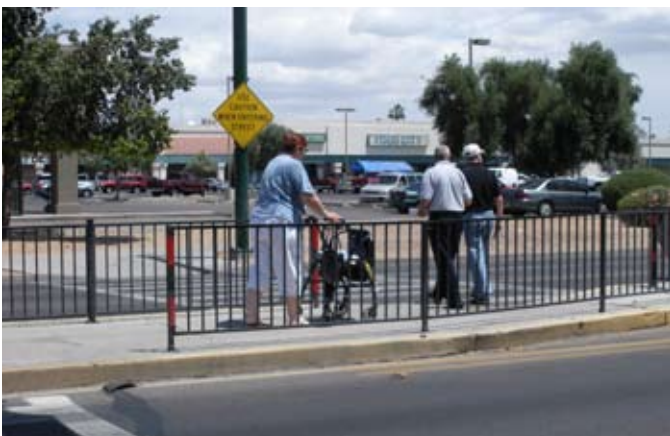
Pedestrian waiting to cross the “second stage” of the West Thomas Road arterial.

- **Remove** debris regularly from the median island.

- **Install** detectable warning surfaces to enhance the safety for visually-impaired pedestrians.
- **Improve** the design of the median island so debris does to accumulate.

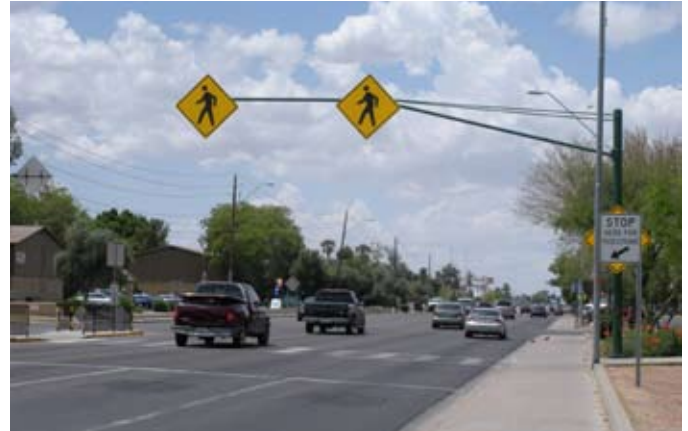
Like the West Thomas Road location, it is also near a signalized intersection. Each approach at this location is augmented by two overhead and one pole-mounted PEDESTRIAN CROSSING warning signs on each approach, in order to improve the visibility of the crossing. As with the other two locations, debris in the median refuge island was a problem. There was some feeling among the review team that with the close proximity of the traffic signal at 19th Avenue and Indian School Road, drivers were less prone to stop for a pedestrian once they had reached their cruising speed.

Overhead and side-mounted signs designating the crosswalk location.

- **Remove** debris regularly from the median island.

- **Install** detectable warning surfaces to enhance the safety for visually-impaired pedestrians.
- **Improve** the design of the median island so debris does to accumulate.

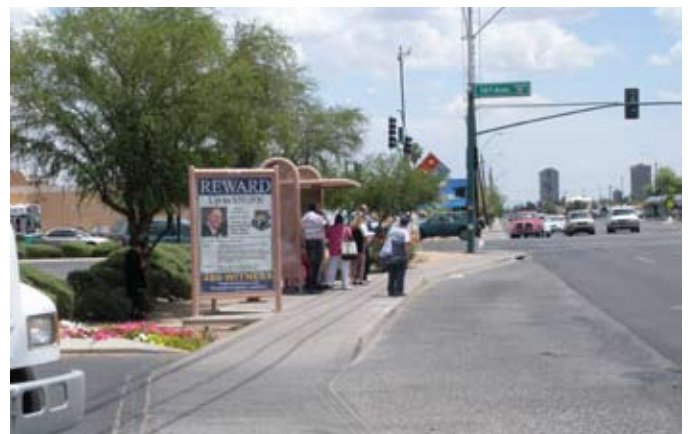
West Indian School Road has substantial pedestrian-transit interaction.

There appears to be little buffer between the sidewalk, parking lot, bus pull-in and the roadway on the north side of West Indian School Road at 19th Avenue. The landscaping, plantings and bus shelter amenities are quite nice; however, the proximity of the traffic to the pedestrians and transit patrons is a negative from an environmental comfort standpoint. It would probably be very difficult to have the shopping center operator eliminate parking spaces to provide a buffer strip for the north side sidewalk. If the area redevelops at some point, this could be a potential.

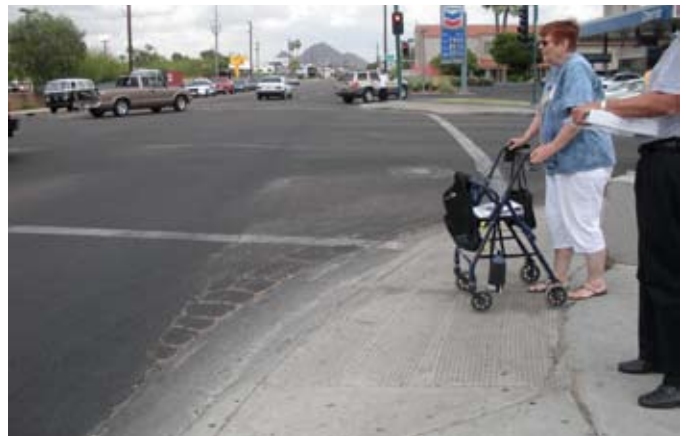
AARP Volunteer Irene Lopez attempts to negotiate the crosswalk at North 7th Street and East Camelback Road.

- **Replace** the existing incandescent pedestrian signal indications with LED countdown signal indications.
- **Trim** landscaping on the southwest corner that is encroaching into the sidewalk area.

- **Install** detectable warning surfaces to enhance the safety for visually-impaired pedestrians.
- **Remove** other obstructions that impede pedestrian traffic.

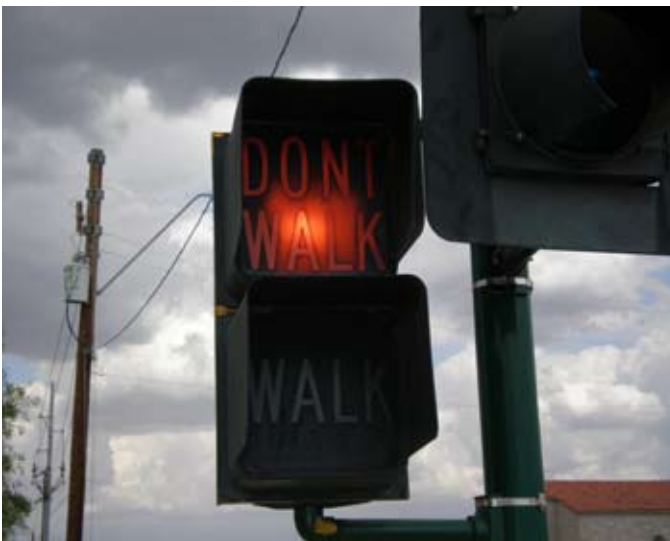
Numerous red-light violations were observed by the team during the safety review of the intersection. Several of the pedestrian signal indications were in poor shape and should be replaced.

Pedestrian crossing signal requiring replacement.

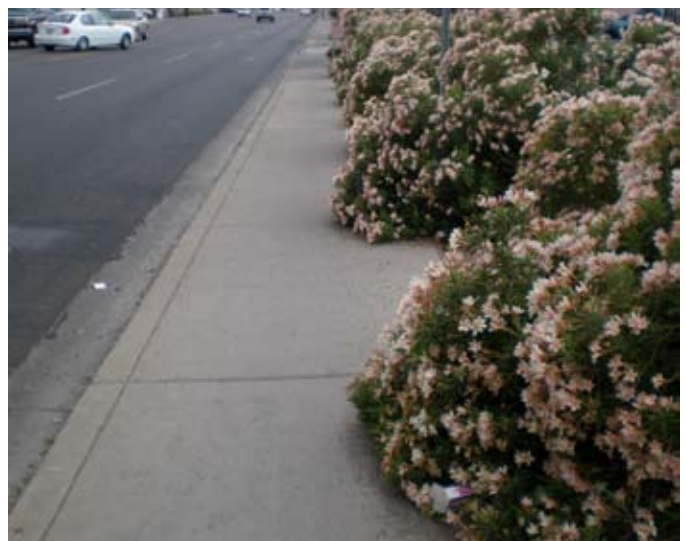
Landscaping encroaching onto the sidewalk.

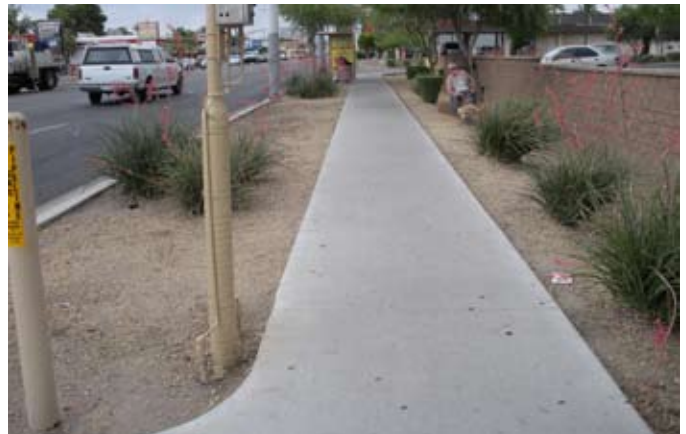
Notice the extensive landscaping and buffering adjacent to the sidewalk; this adds to the environment comfort for walking.
