Split Speed Bump

Kathy Mulder, PE, City of Portland, Oregon*
January, 1998

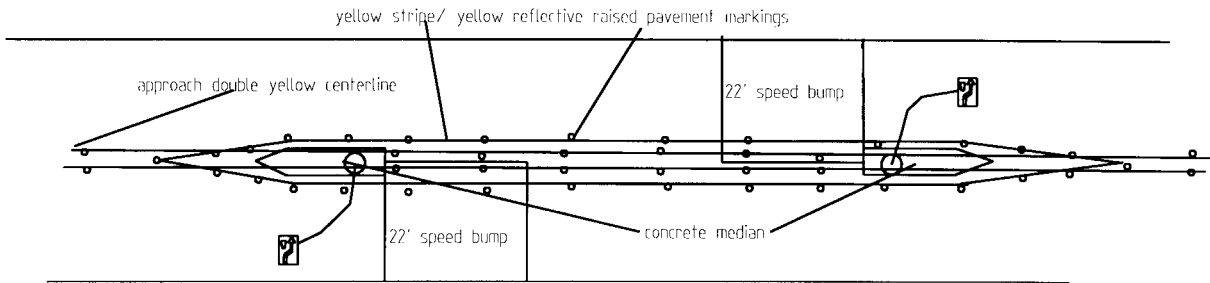
Split Speed Bump Plan

The device was placed approximately 200 feet west of the all-way stop. The first part of the testing was for safety. Concerns of whether automobile drivers would violate the device and chicane between the bumps were raised. Twenty-four hour time lapse

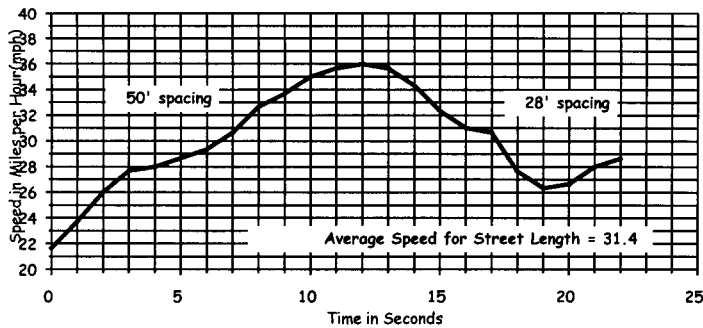
SE Market Speed Bump Test Truck 41 Eastbound - Average

Emergency Emergency vehicles ran timed tests through both of the new split bumps to determine the time lost by each vehicle. A truck and an engine was supplied for the test. These are the vehicles that had the greatest delay per device during the original testing of the other traffic calming devices.

Both vehicles were able to travel the length of the street at speeds between 29 and 31 mph. The vehicle speeds through the 50 foot off-set spacing were 26 mph to 30 mph. Between the 28 foot off-set spacing, speeds were 20 mph to 26 mph. It was found that the actual time lost was no more than 1 to 2 seconds for the largest of the vehicles.

In reviewing the data for the test, it was noted that the slowest speeds, and therefore the most time lost, were at the off-set speed bump with the 28' spacing. The speed for the off-set speed bump with the 50' spacing never went below 25 mph.

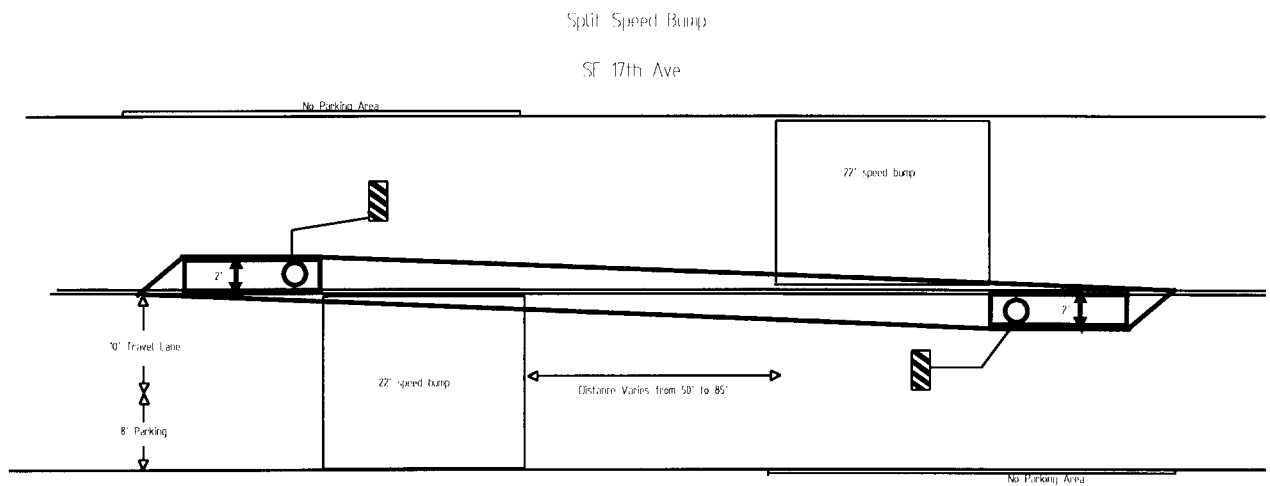
bumps. This incorporated both the 22' length of the bump half, and 7 feet for the approach island. These islands were only 2 feet wide, and set in such a way as to maintain the 10' travel lane. The distances between the bumps ranged from 50' to 85'.
